**ARBORIST'S REPORT**

**6782 SEBASTOPOL AVENUE  
AND  
385 MORRIS STREET**

**SEBASTOPOL, CALIFORNIA**

July 30, 2024

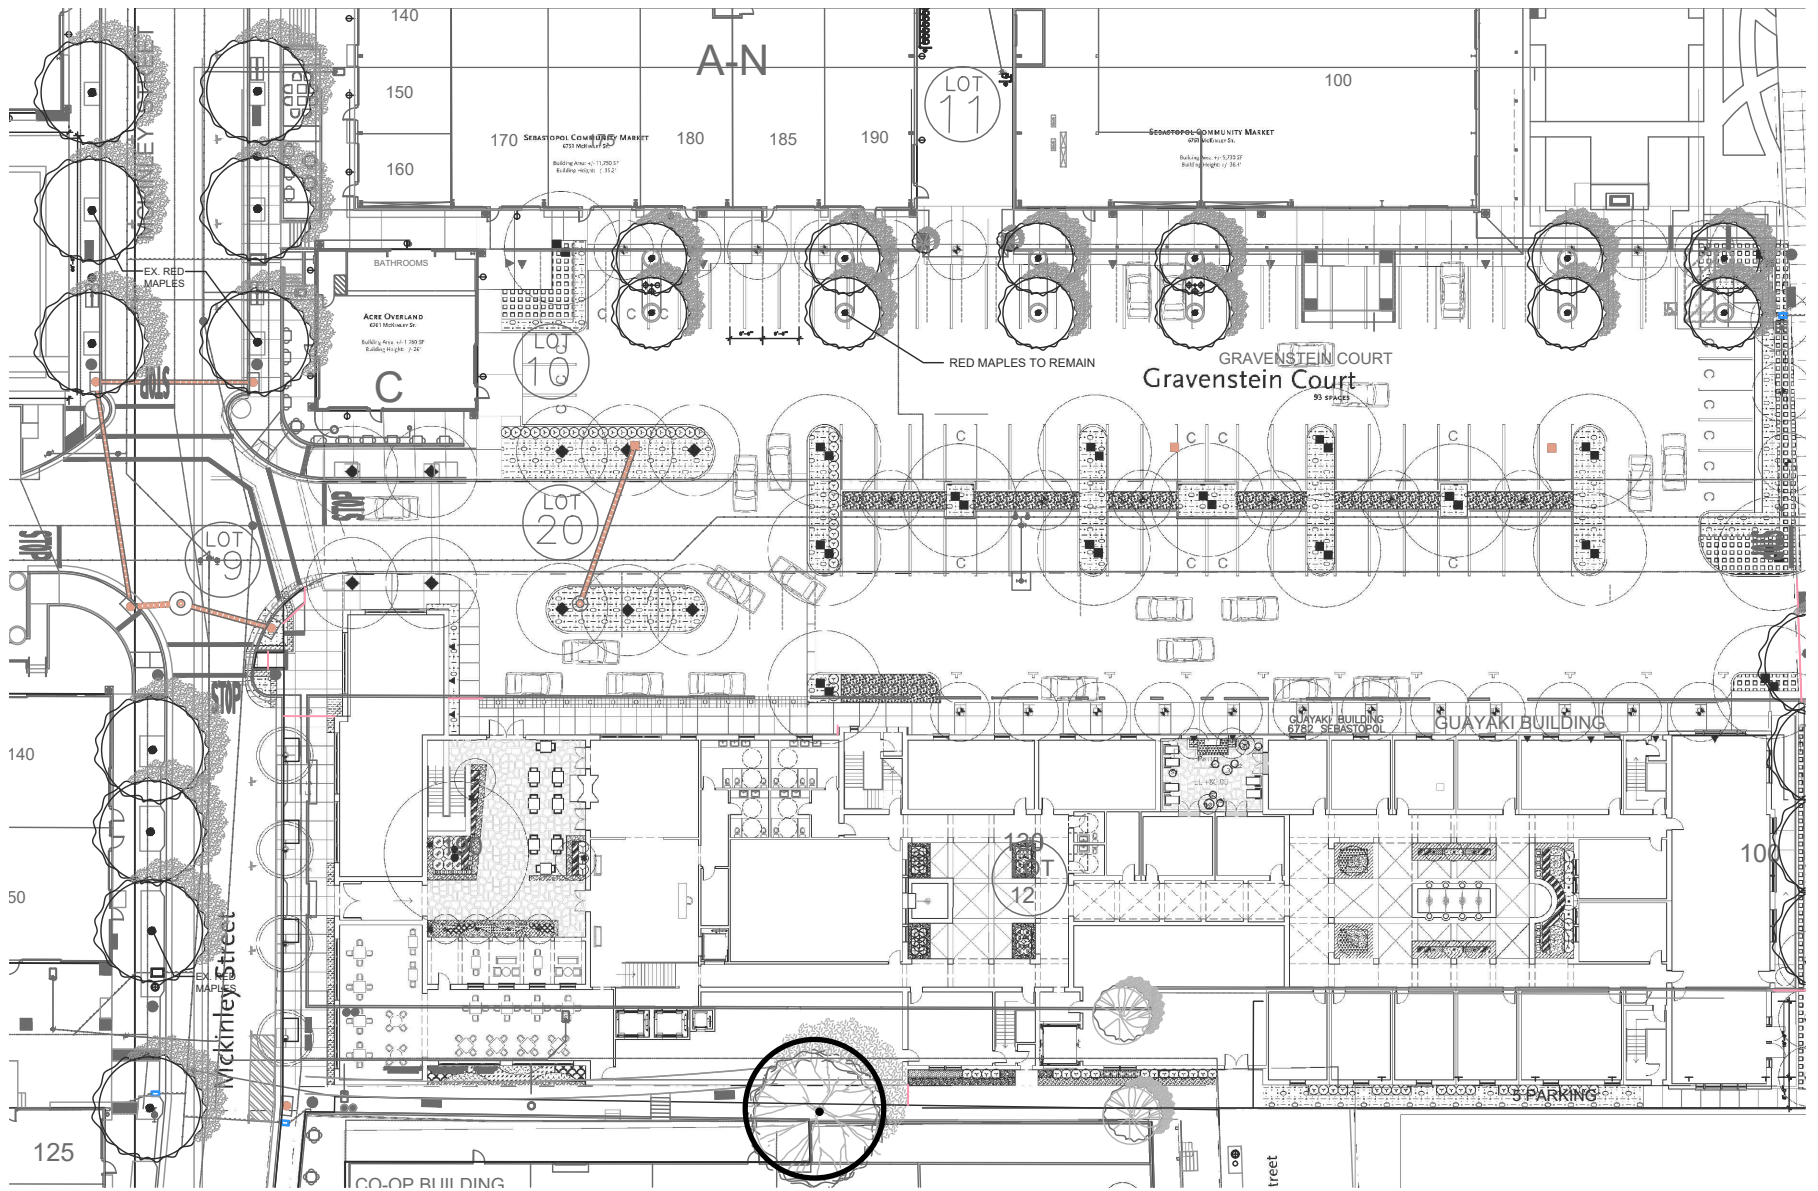
# TREE EXHIBIT

At the hotel site there are no Protected Trees, but there is one Protected Tree directly to the west (APN 004-750-034). The ownership of a tree is determined by where the trunk is located. When a tree trunk is solely on one property that property owner has complete ownership of the tree, regardless of where the foliage or roots are. However, in this case all of the parcels are controlled by The Barlow, so tree ownership is not an issue on this project. Due to the anticipated root loss from the new foundation work for the hotel, this tree is proposed to be removed.

The tree has been previously cabled to address the weak union of the codominate stems. When a tree is cabled it is a permanent solution, and the cables need to be inspected regularly. As time passes the tree will continue to grow which can result in the tree cable being in the wrong location or requiring additional support. The tree itself may develop decay which will reduce the effectiveness of the support system. Cables restrict the natural movement of the tree parts, if the cable is too tight it will add stress to the union it is meant to support. The cable and hardware also need to be inspected to look for any corrosion or degradation. Lack of routine inspection and maintenance will lead to structural failure of the tree or tree parts.

Tree	Species	Diameter	Vigor	Structure	Status	Notes
1	<i>Quercus lobata</i> (valley oak)	27.9"	Fair	Fair/Poor	Remove	Trunk bifurcates at ±8' off grade into two codominate stems, included bark present. A bulge is present at the union indicating an internal crack. Two scaffold limbs (above the trunk union) have been cabled together. Significant woundwood has grown around the eyebolts securing the cable, there was no slack in the cable. The tree was pruned excessively, resulting in many epicormic shoots.
2	<i>Salix lasiolepis</i> (arroyo willow)	Inaccessible	Poor	Unknown	Remove	This tree is growing in an inaccessible thicket. It appeared to be below the threshold of 10" DBH. Trunk diameter to be verified prior to removal.
3	<i>Quercus lobata</i> (valley oak)	±8", ±8", ±8", ±6", ±10"	Good	Good	Save	Tree ±8' beyond the proposed development and ±8' below the top of bank. Due to the past use of the site and the steep grade between the project and the base of the tree, few if any roots are assumed to be present near the parking area.

TREE #1
