City of Sebastopol Design Review Board/Tree Board Staff Report

Subject: Tree Removal Permit

2024-026 555 Norlee Street Removal of Protected Trees

Arborist Report Douglas Fir Behind Unit #537

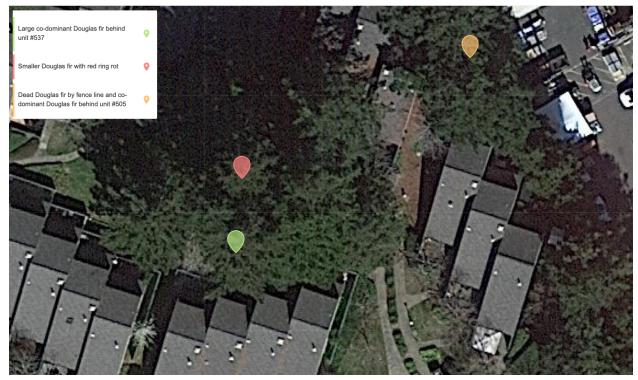
Map 2: Locations of the three trees with structural concerns

Cindy Littrell showed me the property and I surveyed the Douglas Fir behind unit #537 and nearby Douglas fir as well as the Douglas Fir behind unit #505 (Appendix A, Map 2).

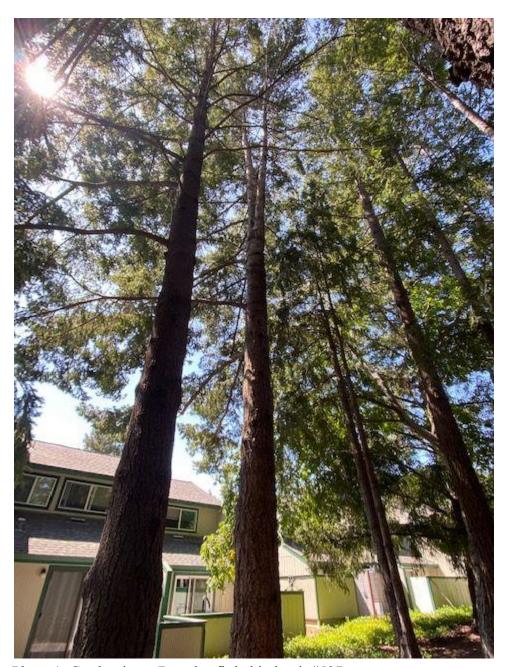
The larger of the two firs requested for removal closest to the adjacent building has a trunk diameter of 30.5 inches and a full canopy with good color. The Merlin report accurately describes the co-dominant union at about 30-40 feet above grade. One of the stems is larger in diameter than the other. The report also notes that "if you remove trees on the edge of a stand, the remaining trees will be exposed to wind and other elements that they have not previously been exposed to. This may destabilize the remaining trees."

tree is not new and shows no signs of partial failure or recent movement. The likelihood of failure is commonly mitigated by subordinating one of the leaders, overall size reduction pruning, installing a cable support system, or a combination of these approaches.

The Douglas fir behind unit #537 has a DBH of 31" and has co-dominant stems at about 30 feet (Appendix B, Photo 1). The larger stem is leaning towards a building and could cause significant damage.

Photo 1: Co-dominant Douglas fir behind unit #537

The trees are all healthy. The red ring rot in the smaller fir does not appear to have advanced to the point of destabilizing the tree. The codominant trunks in the larger fir are a structural defect, but this can be mitigated through standard tree work.

In my experience, codominant unions are among the most common major structural defects in conifers. The codominant union in the large tree is not new and shows no signs of partial failure or recent movement. The likelihood of failure is commonly mitigated by subordinating one of the leaders, overall size reduction pruning, installing a cable support system, or a combination of these approaches.

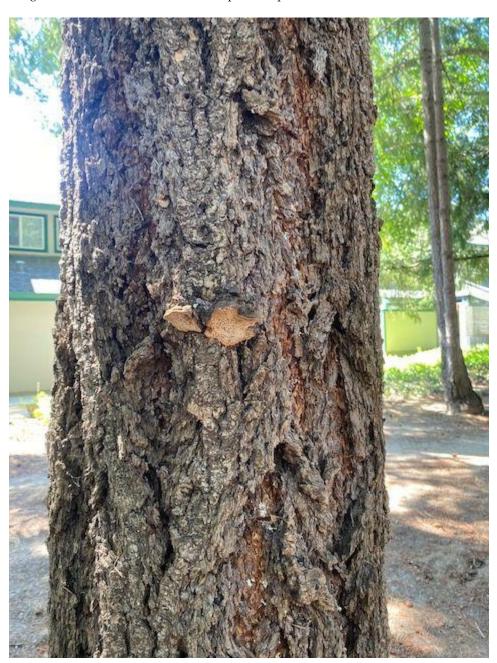
The smaller fir is near the middle of the stand. The red ring rot fruiting body (Porodaedalea pini) mentioned in the Merlin report was removed, but I found some remnants from the conk after reviewing the Merlin photography. The tree has a low live-crown ratio due to its central location in the stand. I sounded the tree with a mallet, and it consistently returned a solid thud associated with sound wood (as opposed to a hollow drum-like resonance).

Red ring rot is a common fungal decay organism in Douglas fir trees. It rots the middle of the trunk but is not known to kill living tissue or decay sapwood. The fungus's fruiting body only indicates its presence in the tree, not the extent of the decay. Trees with only a few conks are typically very stable. It does not affect tree health. In my experience, codominant unions are among the most common major structural defects in conifers. The codominant union in the large

The nearby 17" DBH Douglas fir has **red ring rot** (*Porodaedalea pini*) (Appendix B, Photo 2). It is tall enough to hit structures but is likely to get caught in other trees.

Photo 2: 17" Douglas fir with red ring rot

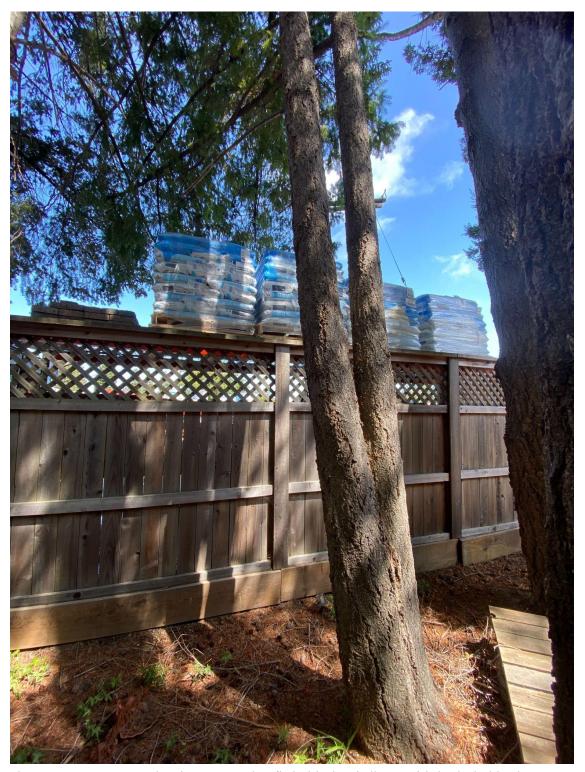
Behind unit #505 is a 17" DBH co-dominant Douglas fir with **included bark** (Appendix B, Photo 3). If it fails it is likely to hit the fence and the Sebastopol Hardware yard.

The trees I was most concerned about that were not already planned for removal are the large Douglas fir tree behind unit #537 and nearby Douglas fir with red ring rot. These trees have structural defects and could impact property or people if they were to fail. The larger co-dominant Douglas fir behind unit #537 is likely to hit a building and could cause significant damage. The co-dominant Douglas fir behind unit #505 has a weak attachment and could hit property if it were to fail.

Photo 3: 17" DBH co-dominant Douglas fir behind unit #505 with included bark
