**Re: Arboricultural Services for the Proposed Barlow Hotel Parking
Lot Located at 385 Morris Street in the City of Sebastopol, CA.**

ARBORIST'S REPORT

**6782 SEBASTOPOL AVENUE
AND
385 MORRIS STREET**

**Re: Arboricultural Services for the Proposed Barlow Hotel Project Located at
6782 Sebastopol Avenue & 385 Morris Street in the City of Sebastopol, CA.**

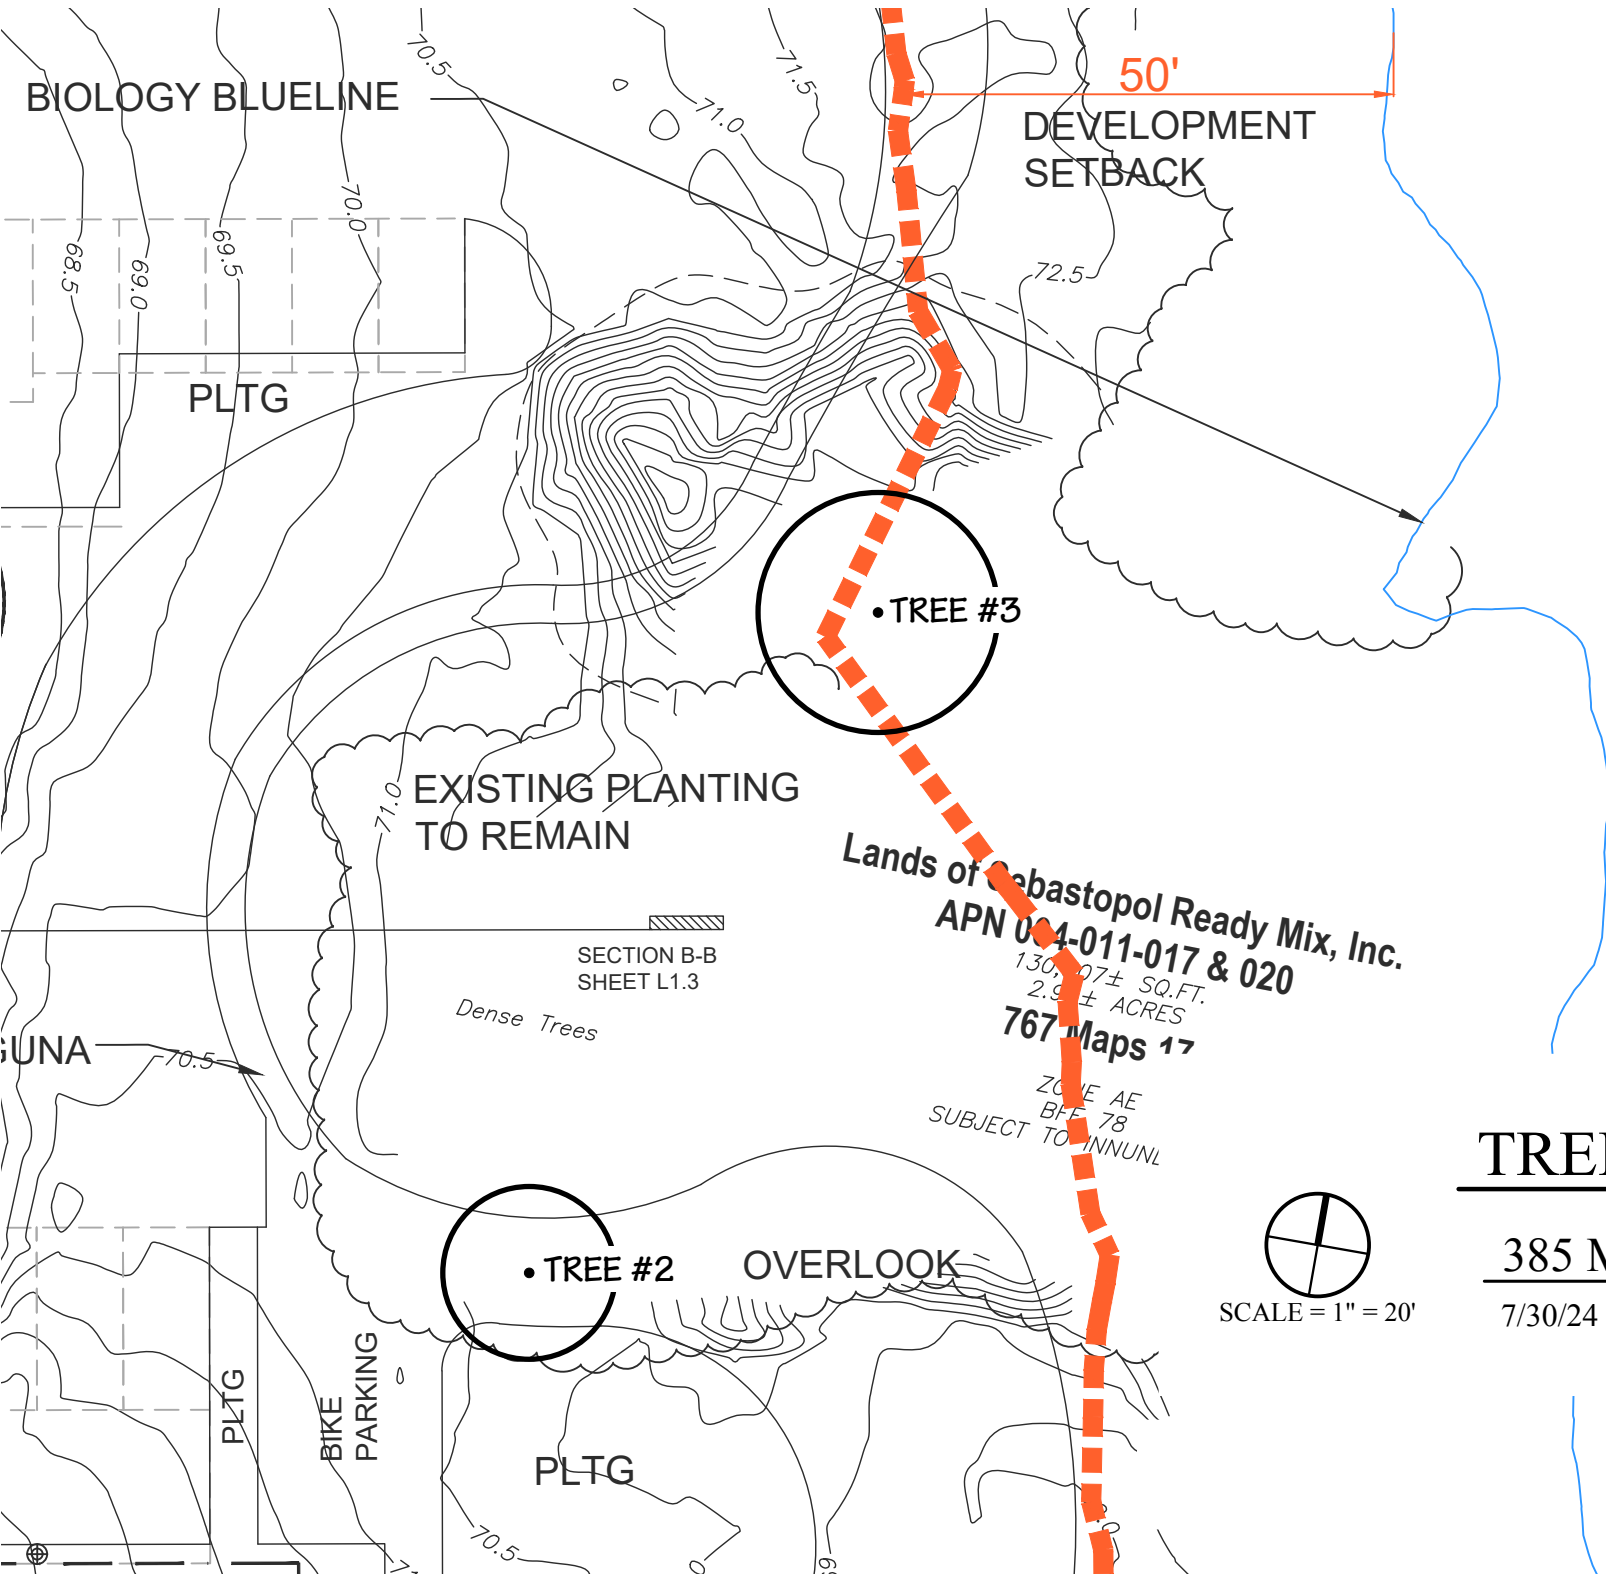
TREE EXHIBIT

Yesterday the photos were provided, combined with my original fieldnotes, I am able to state that Tree #2, is actually a group of small trees. They all appear to be *Salix lasiolepis* (arroyo willow), which is a protected species, but all of the trees are well below the 10" DBH requiring a Tree Removal Permit. Indeed, none of the trees appeared to exceed 4" in diameter.

Trees #4 and #5 are at the north end of the site. Tree #4 is also an arroyo willow, this tree is clearly a Protected Tree and would require a permit for removal. However, it is located a distance away from the limits of the proposed parking lot and more detailed drawing of the proposed work are necessary to make a final determination if removal would be necessary. Tree #5 is a *Salix babylonica* (weeping willow), and would only require a permit were it to be 20" DBH or greater. The photos provided clearly indicate it is well below the threshold and a permit would not be needed.

4	<i>Salix lasiolepis</i> (arroyo willow)	Inaccessible	Good	Unknown	Remove	This tree is growing in an inaccessible thicket. It appeared to be below the threshold of 10" DBH. Trunk diameter to be verified prior to removal.
5	<i>Salix babylonica</i> (weeping willow)	Inaccessible	Poor	Fair/Poor	Remove	This tree would only require a Tree Removal Permit if the trunk ≥ 20". Trunk diameter to be verified prior to removal.
